Manhole Inspection Summary

Manhole # S33YY1013MH

Location Address: **215 SAINT DUNSTANS RD** Cross Street: **PURLINGTON WAY**

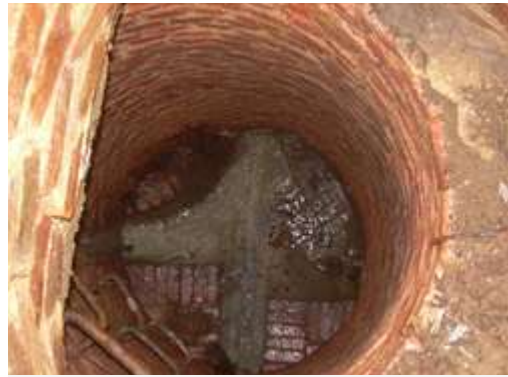
Top View

Corroded steps. Bench debris.

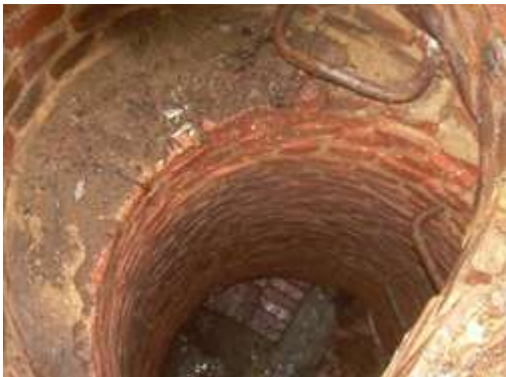
Defect

Adjustment and Corbel infiltration - other side.

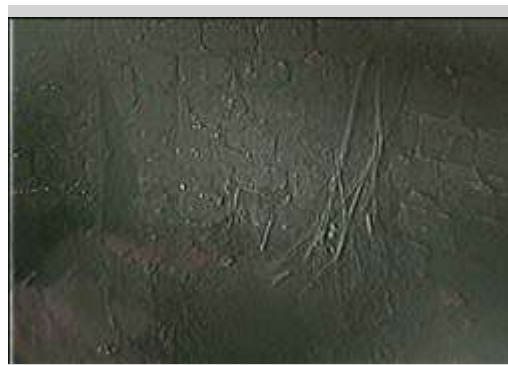
Defect

Barrel deterioration, root intrusion and infiltration.

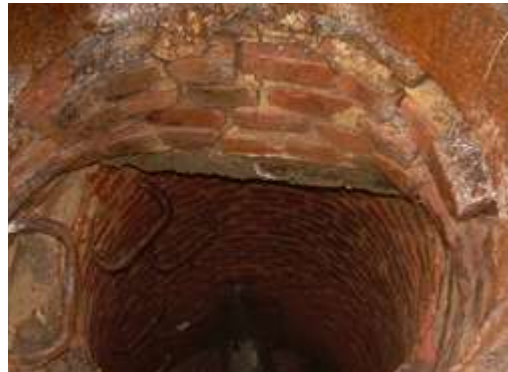
Defect

Frame leaks. Adjustment deterioration, loose brick and infiltration. Corbel infiltration.

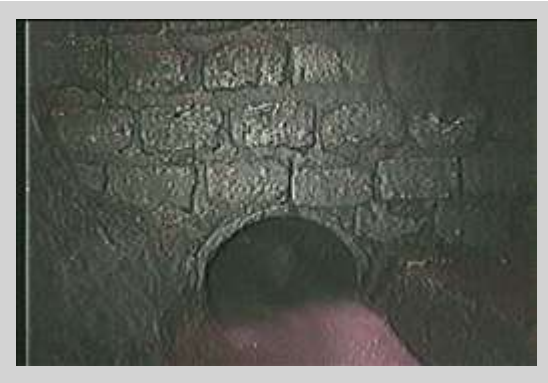
8 in. Circular Gravity Sewer Pipe Out @ 12 O'Clock

Barrel deterioration and infiltration.

Infiltration: **Evidence** Pipe Seal Cond: **Cracked**

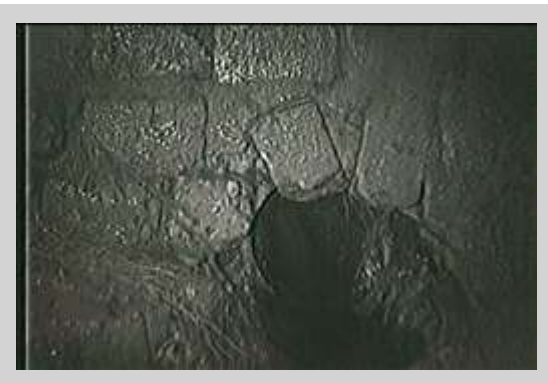
8 in. Circular Gravity Sewer Pipe In @ 4 O'Clock

Barrel, Bench and Channel root intrusion.

Infiltration: **Evidence** Pipe Seal Cond: **Roots**

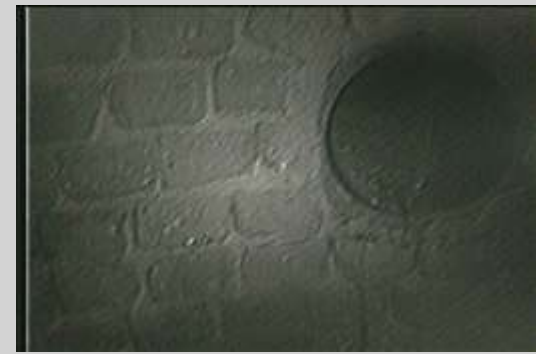
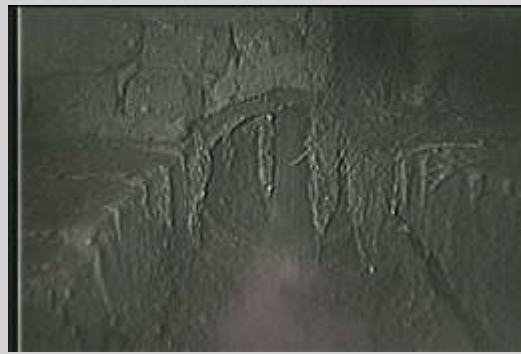
Pipe In @ 6 O'Clock

Barrel root intrusion and infiltration. Channel deterioration.

Infiltration: **Evidence** Pipe Seal Cond: **Roots**

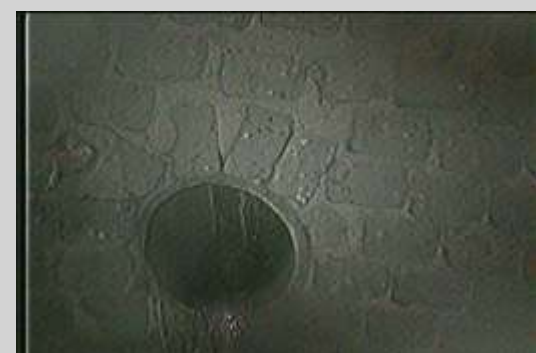
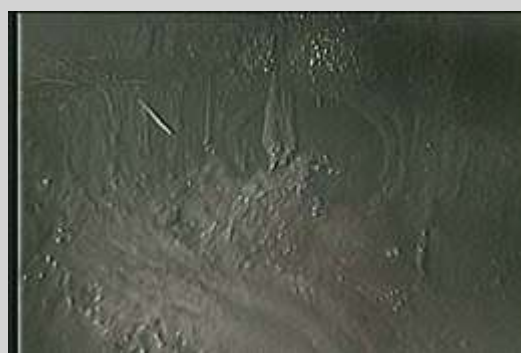
Pipe In @ 9 O'Clock

Barrel root intrusion and infiltration. Channel deterioration.

Infiltration: **Evidence** Pipe Seal Cond: **Unknown**
